Трагови пожара у случајевима самозапаљења аутомобила¹

Циљ овог рада је да укаже на специфичне трагове у случајевима самозапаљења возила, и то када је пожар избио у простору око мотора и у кабинџ возила.

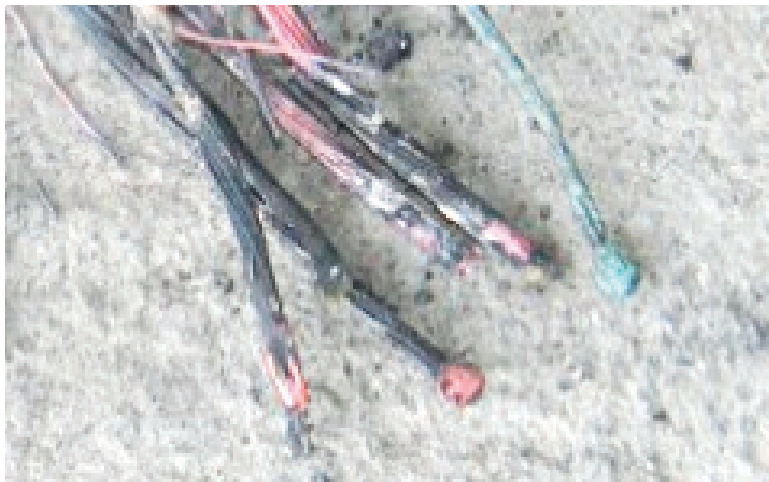
Фотографија 1. Трагови кратких спојева – узроковачи пожара

Узрок паљења могу бити: прегревање електричних проводника, намотаја и других уређаја кроз које протиче електрична струја, кратак спој, варничење и електротермички уређаји и направе (Алексић, Костић, 1982: 40). Код свих ових узрока остаје карактеристичан траг топљења проводника у виду облих и чврстих промена попречног пресека проводника – у виду „куглица”, задебљања, суза, бобица и слично. Ти карактеристични трагови настају као последица варничења и кратког споја или електричног лука, а могу се наћи на самим проводницима или у њиховој ближој околини на присутним материјалима.

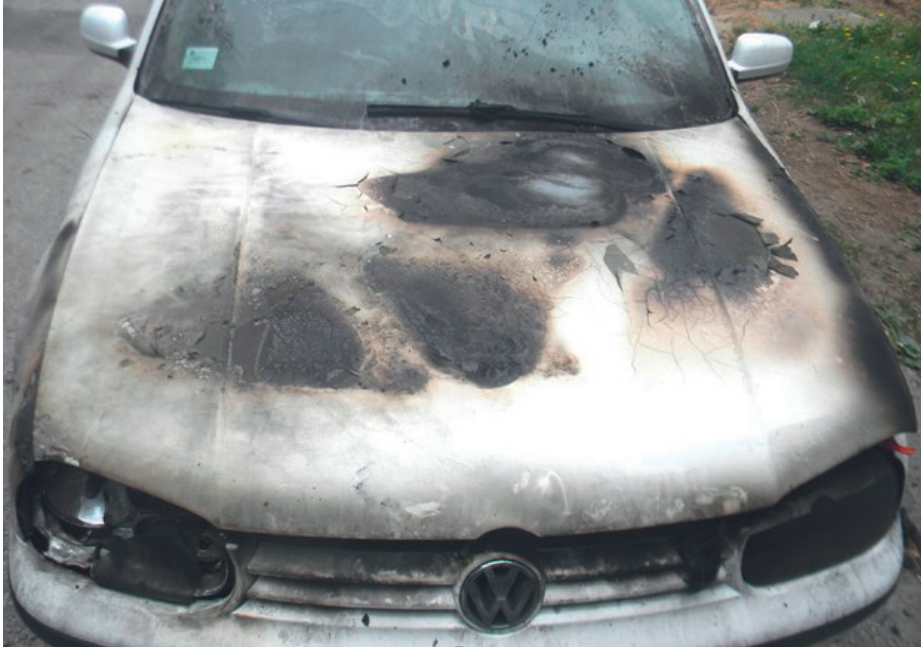
Фотографија 2. Печатно прегоривање на поклопцу мотора са спољашње стране

На фотографијама 2 и 4 приказани су специфични трагови који указују да је пожар почео испод поклопца мотора возила док је он био у затвореном положају.

Ови трагови се могу пронаћи на спољашњој површини поклопца мотора, по ивицама поклопца мотора, на унутрашњој површини поклопца мотора и на електроинсталацијама испод поклопца мотора. Сваки пронађени траг треба детаљно, јасно и стручно образложити и поткрепити фотографијама у складу са правилима струке.

На фотографији број 2 на спољашњој површини поклопца мотора уочава се местимична термичка деградација у виду „печатног“ прегоривања боје и лака са јасно дефинисаним обликом. Између прегорелих печата уочавају се површине које нису у потпуности прегореле. Оне ограничавају и раздвајају ове „печате“, очигледно их издвајајући из целине. Овакав траг нам показује смер кретања пожара, односно указује да се ради о пожару који је почео испод поклопца мотора, односно изнутра. Наиме, да је пожар почео споља, на спољашњој површини поклопца мотора, горива материја (боја и лак) сагоревала би равномерно, ширећи се у свим правцима,

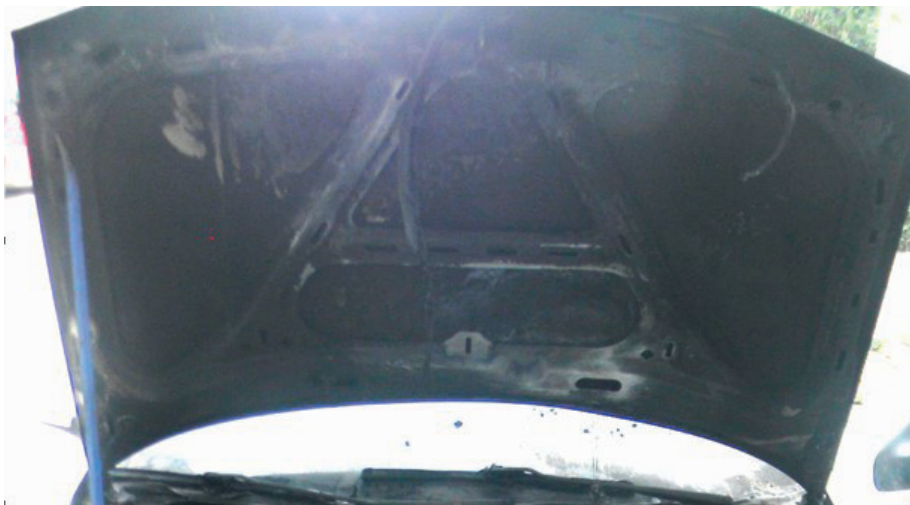
Фотографија 3. Ојачања поклопца мотора са унутрашње стране

Међутим, ако пажљиво погледамо фотографију број 3, уочићемо да поклопац мотора са унутрашње стране има своју (фабричку) конструкцију, односно металне греде које су костур поклопца мотора. Ове греде се у пожару понашају као препреке за равномерно кретање пламена и температуре. Оне температуре и пламену физички не дозвољавају равномерно кретање. Зато пожар оставља „пресликану шару” на лицу поклопца мотора. Искусни криминалисти, посматрајући спољашњу површину поклопца мотора, могу претпоставити облик његове конструкције која се налази на унутрашњој страни поклопца.

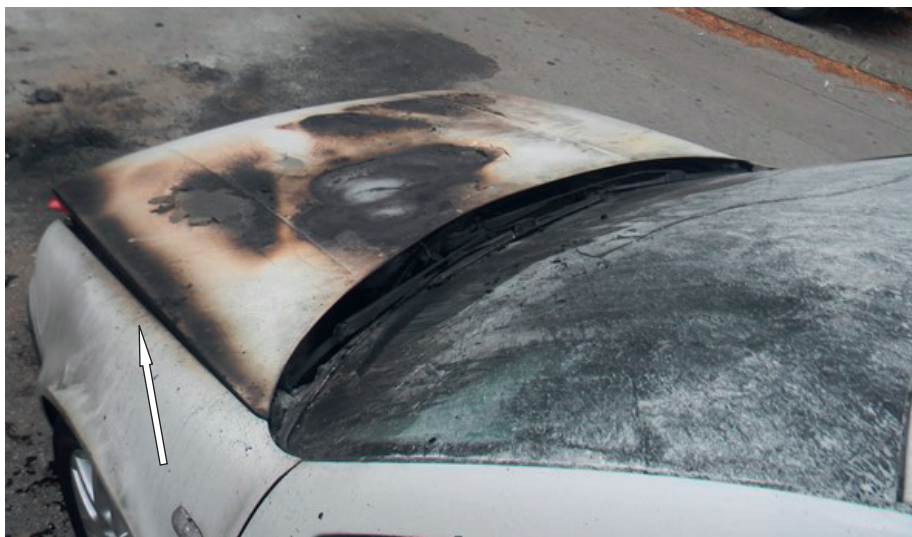
Фотографија 4. Димни ореол на ивици поклопца мотора

Димни ореол је још један у мноштву трагова које можемо пронаћи у склопу криминалистичко-форензичке обраде аутомобила који су горели (фотографија 4). Тај траг одбацује могућност постојања поспешивача горења на поклопцу, али и могућност да је спољашност поклопца мотора место настанка пожара. Да је површина поклопца мотора поливена неким поспешивачем горења, рецимо бензином, он би се сливао под утицајем гравитације и имали бисмо, сасвим сигурно, трагове прегоревања предње ивице поклопца мотора као најниже тачке поклопца мотора.

Овако, без сумње одбацујемо присуство поспешивача горења, али и спољашњост поклопца мотора као место настанка пожара. Наиме, димни ореоли у виду зацрњења по ивицама поклопца мотора и непосредно испод њих несумњиво показују да је туда пролазио дим и са њим продукти сагоревања, који су се хватали за површину поред које су пролазили. Пошто се дим увек креће одоздо нагоре, несумњиво је да је место настанка пожара испод поклопца мотора.

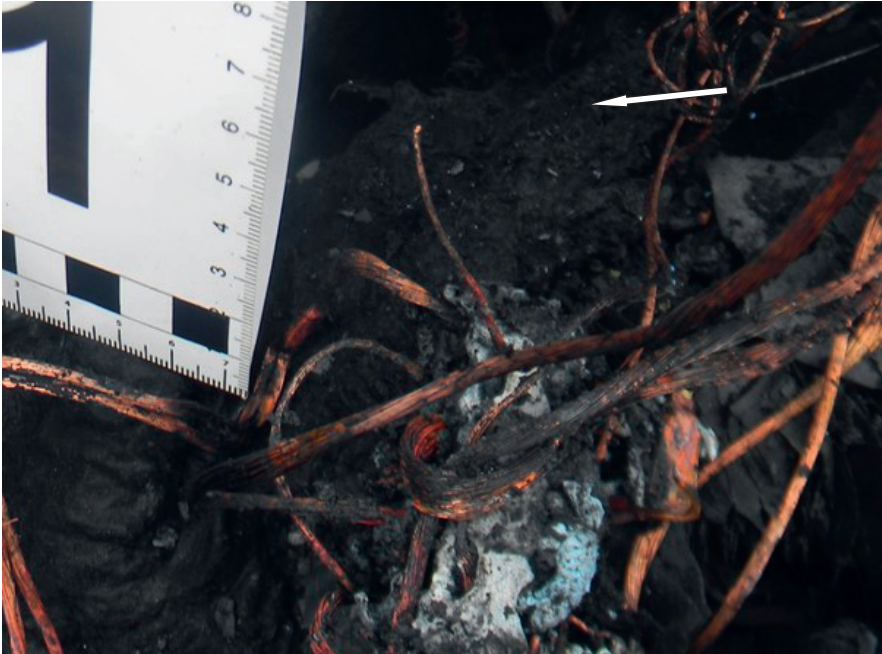
Фотографија 5. Траг кратког споја

Детаљним прегледом центра пожара, на крају проналазимо и сам узрок пожара, односно карактеристичан траг затопљења бакарног проводника у виду прекинутог проводника са заобљеним ивицама прекида, настао на добро познат начин који смо већ описали (Фотографија 5).

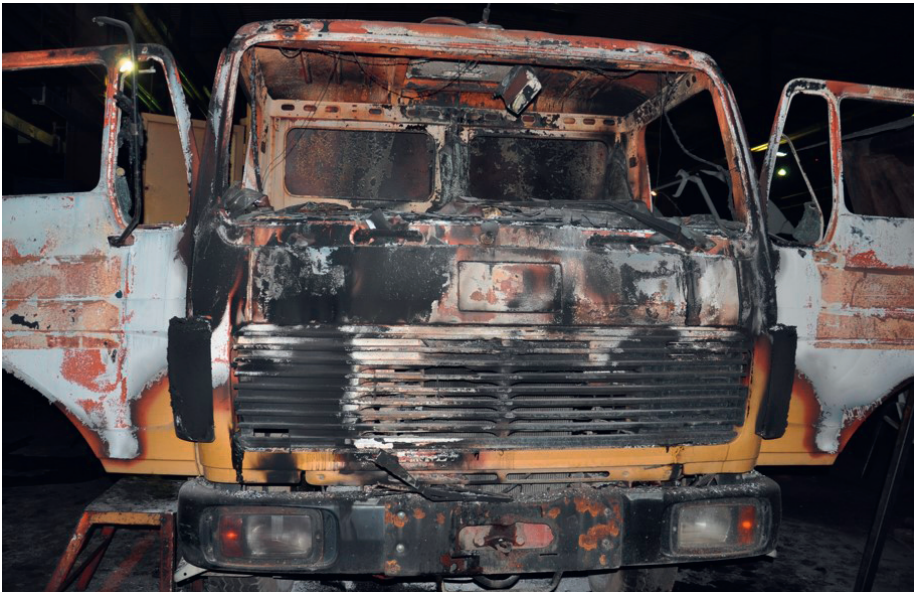
Фотографија 6. Изглед камиона када је пожар почео у кабини, а узрок је кратак спој на инсталацијама у пределу осигурача

Центар пожара ће по правилу бити место на којем су најизраженија таква оштећења и оно се најчешће подудара са местом избијања пожара. Свакако, динамика развоја пожара је таква да ће најпре сагорети унутрашњи гориви материјали, онда спољашњи и тек на крају материјали на најдоњим деловима возила (доњи део врата, доње бочне ивице, подножје возила). Уколико се пожар на возилу у чијој је кабини дошло до самозапаљења локализује и угаси или самогаси, возило ће изгледати као на фотографијама 6, 7 и 8.

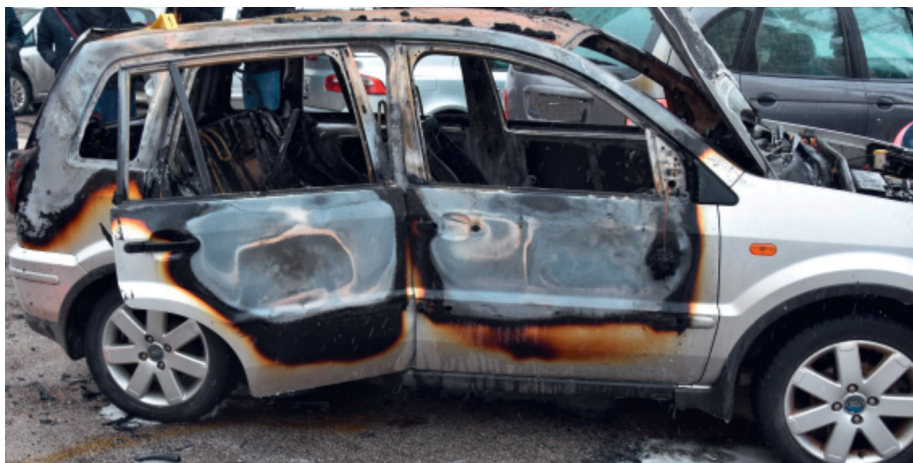
Фотографија 7. Изглед бочне стране возила у ком је дошло до самозапаљења услед квара на инсталацији грејача у возачевом седишту

На фотографијама 7 и 8 уочава се школски пример центра пожара у кабини возила, који одликује доња граница горења на вратима и доњим бочним ивицама возила. На тим местима готово увек овако остаје несагорела горива материја (боја и лак) са јасним границама горења, **која није вертикално прекинута**. Пружа се дуж доњих бочних ивица и углавном има „исту” висину, како је приказано на фотографији број 8.

У таквим ситуацијама описани траг је теже уочљив, али ипак може постојати и може се направити разлика у горењу горњих и доњих делова врата, а може се и фиксирати фотографијом. Овај траг нас наводи на закључак где је центар пожара, те на том месту треба тражити и узрок пожара.

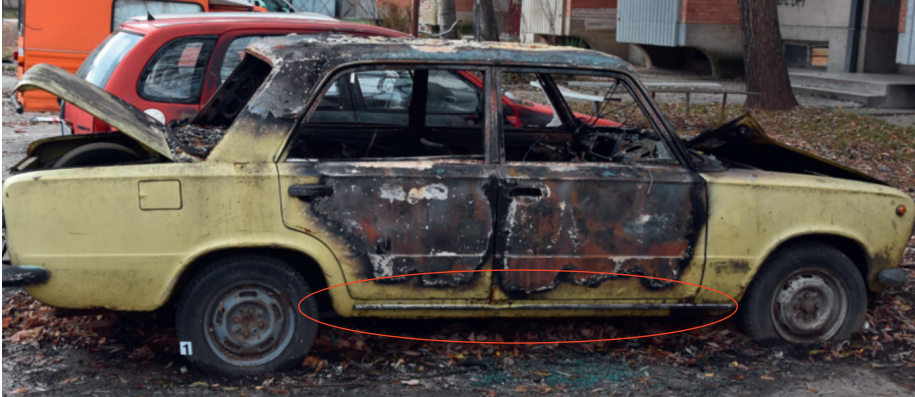
Фотографија 8. Изглед возила након самозапаљења централне конзоле унутар кабине

Али, ако постоји било какав вертикални прекид овог трага, то указује на могућност присуства лако запаљиве течности, која је услед горења током сливања направила тај прекид. У том случају се анализира садржај испод прекида, па се он повезује са другим горивим материјама испод прекида и у његовој непосредној близини. Наиме, могуће је и да неки картон, папир, гума, пластика и сл. услед горења направе тај прекид, што морамо узети у обзир. Уколико нема трагова неког лако запаљивог материјала испод возила, вероватно се на том месту сливала лакозапаљива течност, направивши тако левкасто оштећење услед локалног горења. Можемо је потражити у подлози непосредно испод прекида, а самим тим и доћи до центра и узрока пожара.

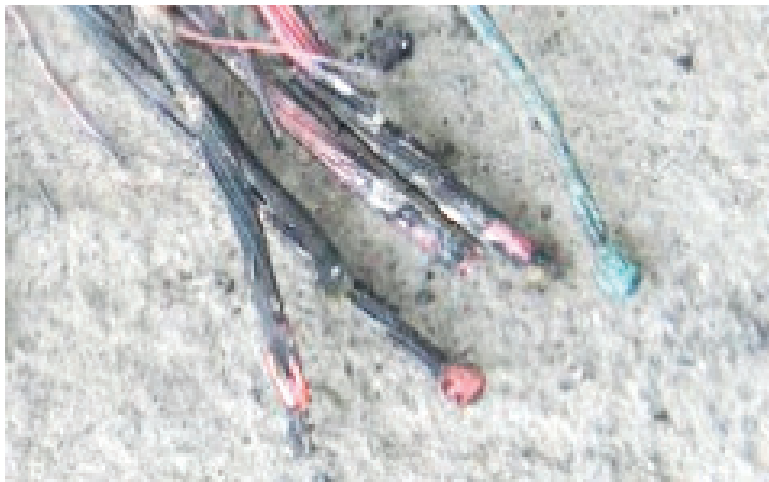
Photograph 1. Traces of short circuits - causes of fire

The causes of fire can include: overheating of electric conductors, coils or other devices that conduct electrical power, a short circuit, sparks, and electrothermic devices (Aleksić, Kostić, 1982:40). All of these causes leave characteristic traces of conductor melting in the form of round and solid changes in the cross-section of the conductor – the form of ‘balls’, bulges, tears, berries, etc. These characteristic traces occur as a consequence of sparks, short circuits or electric arc, and can be found on the conductors themselves or on the materials present in their immediate proximity.

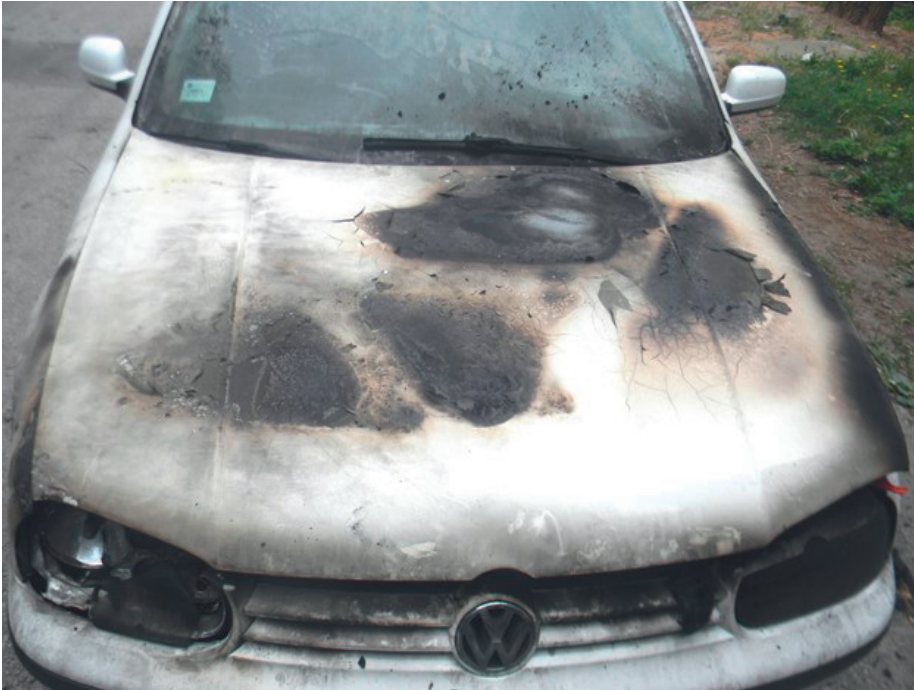
Photograph 2. Seal-like burning marks on the outside of the hood

Photographs 2 and 4 show specific traces which indicate that the fire started under the hood of the car engine while it was in a closed position.

These traces can be found on the outer surface of the hood, alongside hood edges, on the inside of the hood and on electrical installations under the hood. Every trace that is found needs to be meticulously, clearly and expertly elaborated on and accompanied by photographs in keeping with the rules.

Looking at the photograph no. 2, partial thermic degradation may be noted on the outside surface of the hood in the form of ‘seal-like’ burnt patches of paint and varnish of clearly defined forms. Between the burned ‘seals’, surfaces may be observed that are not completely burnt. These surfaces delineate and separate these ‘seals’, apparently making them stand out from the whole. This trace indicates the direction of fire spreading, that is, it shows that fire started under the engine hood, from the inside. Namely, if the fire had started on the outside, on the external surface of the hood, combustible materials (paint and varnish) would

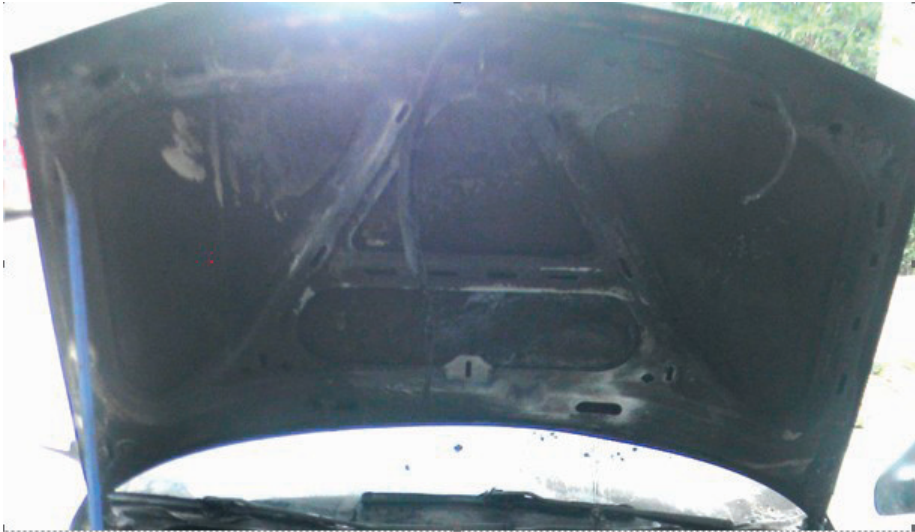
Photograph 3. Hood reinforcement on the inside

However, if we carefully examine Photograph no. 3, we may notice that a reinforcement structure on the inside of the hood, that is metal beams that constitute the skeleton of the hood. These beams act as obstacles in cases of fire, as they hamper uniform movement and development of flame and temperature. They physically prevent the temperature and flame to spread evenly. That is why the fire leaves ‘a pattern’ on the outside surface of the hood. Experienced crime scene investigators can draw conclusions regarding the design of structure on the inside of the hood when they see the its outer surface.

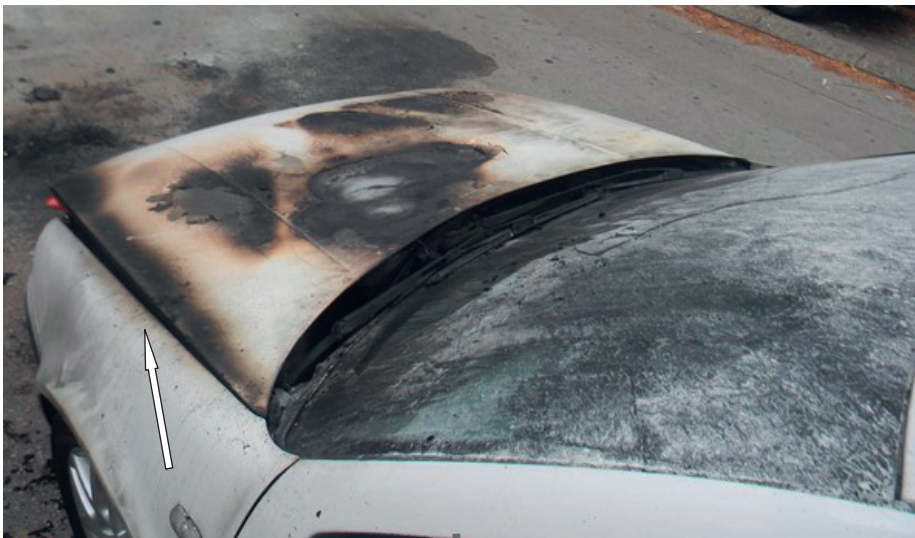
Photograph 4. Smoke halo on the edge of the hood.

A smoke halo is yet another in the multitude of traces that may be found in the course of fire scene investigation and forensic processing of burned cars (Photograph 4). This trace rules out both the possibility of combustion accelerator presence on the hood and the possibility that the fire started on the outside surface of hood. If the surface of the hood had been splashed with combustion accelerating agent, such as, for instance, petrol, it would drip under the influence of gravity and we would quite certainly have traces of overheating on the front edge, as the lowest point of the hood.

In this way we undoubtedly exclude the presence of a burning agent but also the outside surface of the hood as the place where fire originated. Namely, smoke haloes in the form of blackening of hood edges and the area immediately beneath them indicate without any doubt that smoke passed by them along with other products of burning, which stuck to the surface on their way out. As smoke always moves upwards, there can be no doubt that the fire started under the hood.

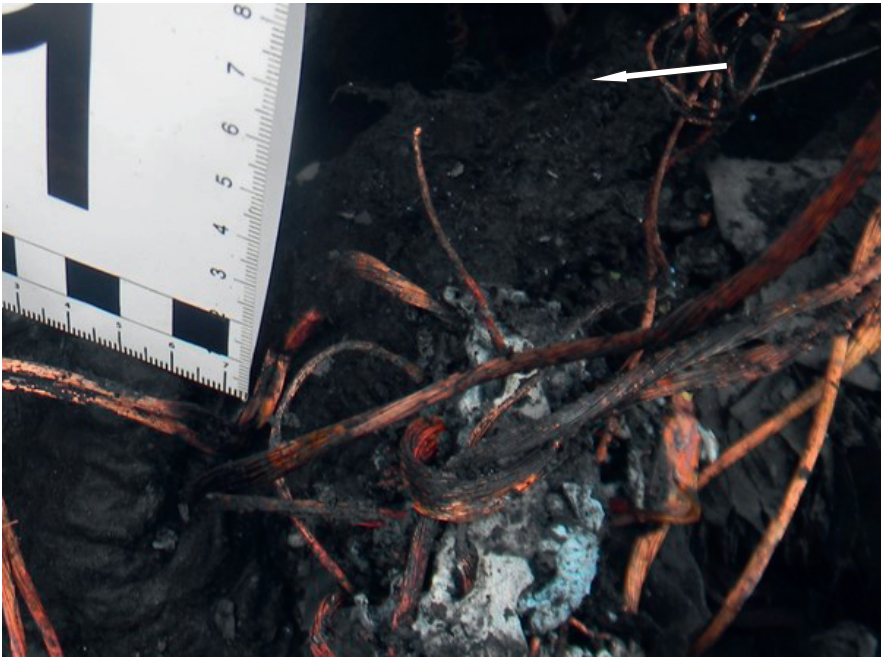
Photograph 5. The trace of a short circuit.

After a detailed inspection of the fire center, we finally establish the cause of fire, that is, the characteristic trace of melted copper conductor in the form of interrupted conductor with rounded edges at the interruption, originating in a well-known way that has already been described (Photograph 5).

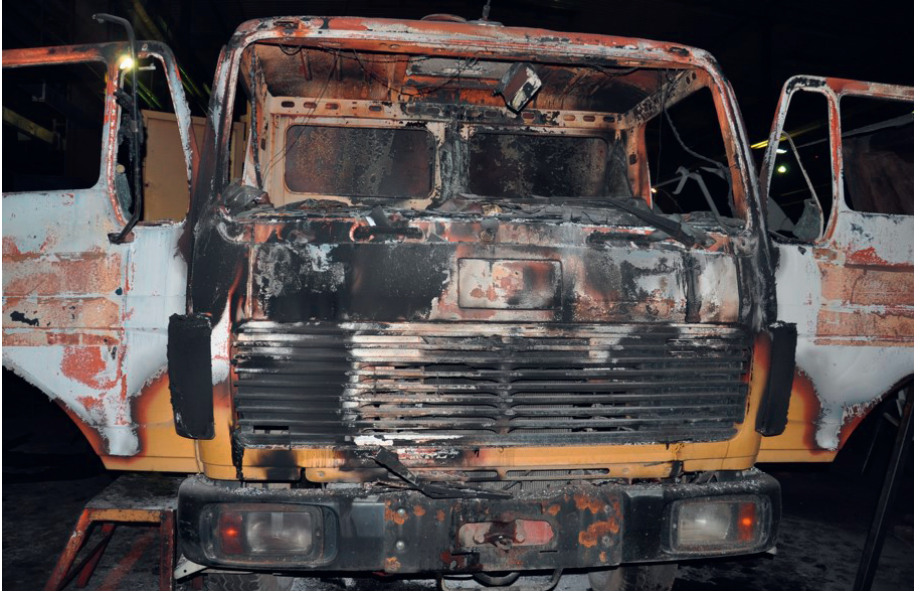
Photograph 6. The appearance of a truck in which fire started in the cabin due to a short circuit on the installation around the fuse

The fire center will as a rule be the spot where such damage is most prominent and it will most frequently match the place where the fire started. The dynamics of fire spreading is such that naturally, the combustible materials on the inside will be the first to burn, then those on the outside and finally the materials at the lowest points of the vehicle (the bottom section of the doors, lower side edges, the foot of the vehicle). If the fire is localized, extinguished or goes out in a vehicle in whose passenger area self-ignition occurred, the vehicle will look as in the photographs 6, 7, and 8.

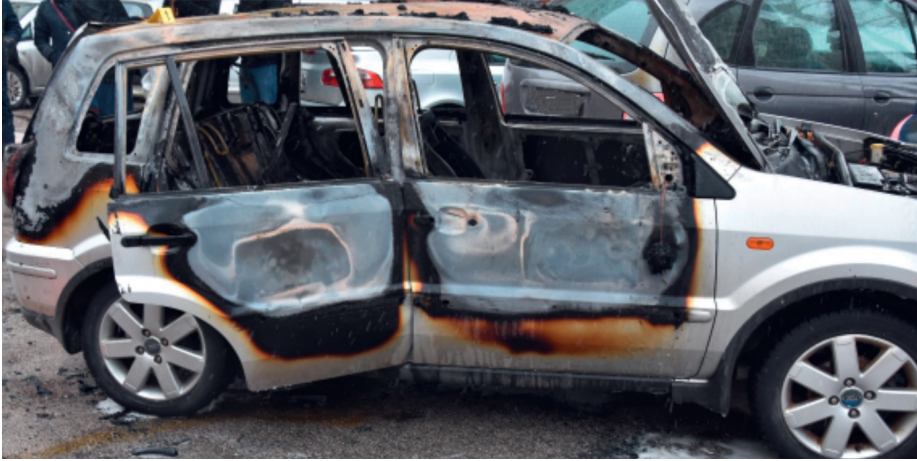
Photograph 7. The appearance of a vehicle side affected by spontaneous burning due to a defect on the heating installations in the driver's seat

Photographs 7 and 8 show a typical example of a fire center in the passenger area, which is characterized by the lower burning line on the doors and on the lower side edges of the vehicle. These are the places where unburnt combustible matter (paint and varnish) always remains, clearly delineating the burning on the door, **which is not vertically interrupted**. It stretches along the lower side edges, mostly at the same height, as shown in Photograph no. 8.

In such situations, the described trace is more difficult to spot, yet it may be present, so a distinction can be drawn between burning of upper and lower parts of the door, and the trace can be preserved in a photograph. This trace may lead us to a conclusion as to where the center of fire was and it is the place where we should look for the cause of fire.

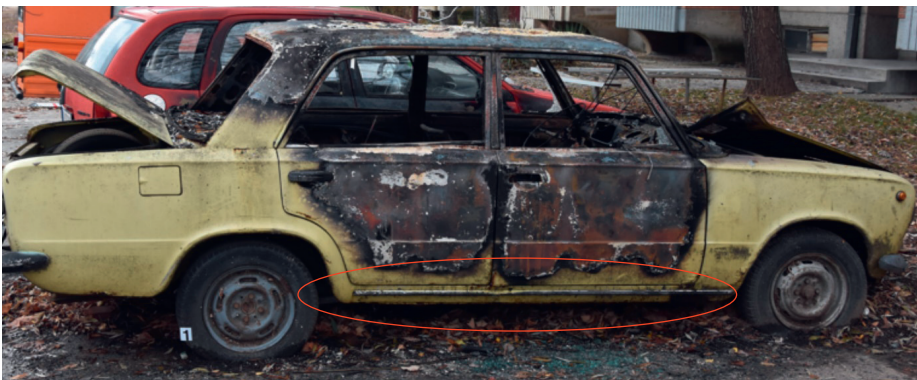
Photograph 8. The appearance of a vehicle following self-ignition of the central console inside the passenger area

If there is any vertical interruption of this trace, it indicates the possibility of presence of a highly flammable fluid, which left the interruption due to burning while flowing. In this case, the content found under the interruption is analyzed, compared against other combustible
